Analyzing Boatside Water-Shock Hazards

IBEX, October 12, 2007

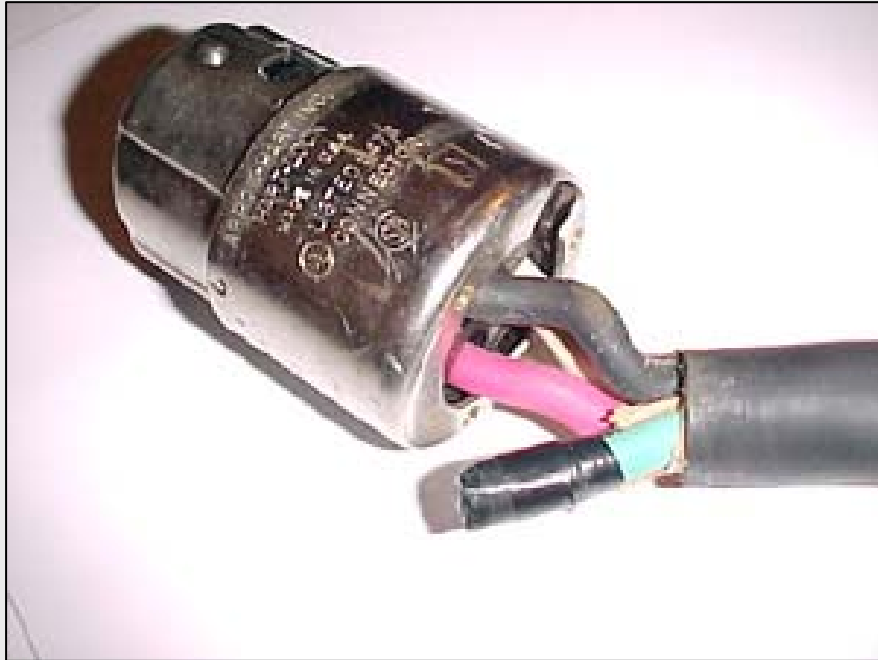
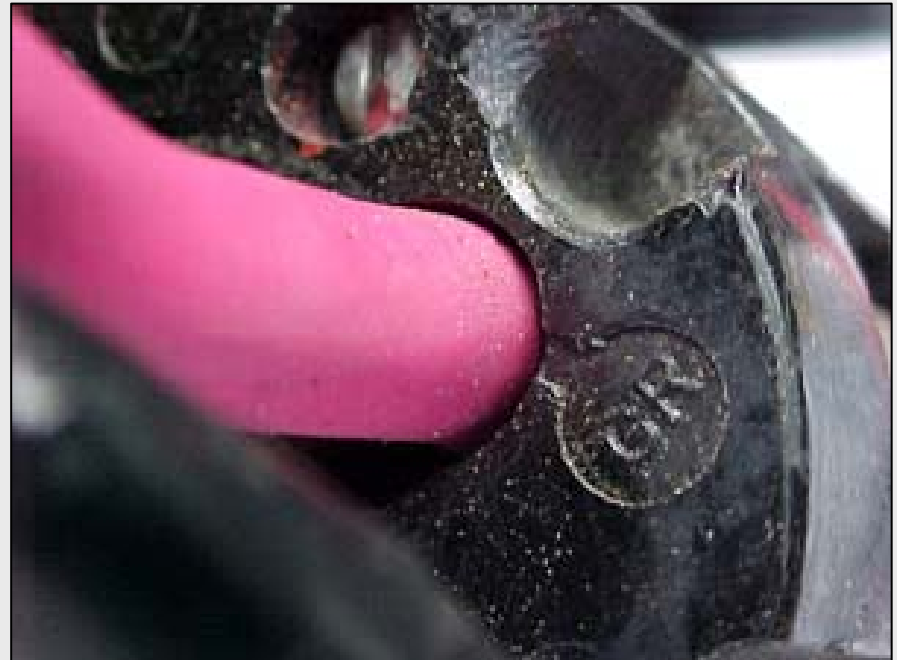
- Can you find the 2 faults here which killed a mother and daughter on Lake Cumberland in May of 2002?
- This plug was wired by the husband/father

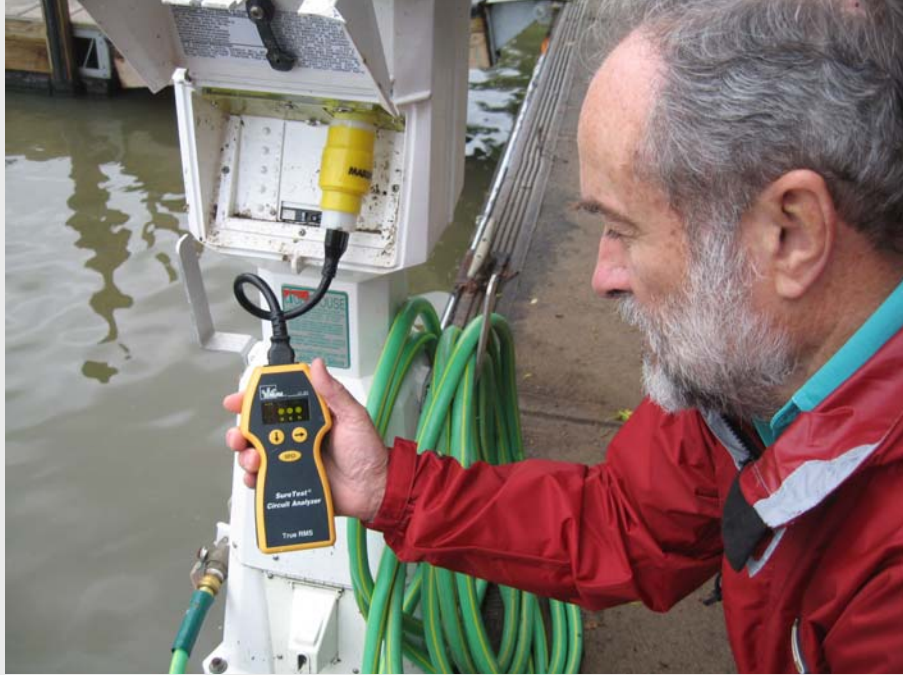
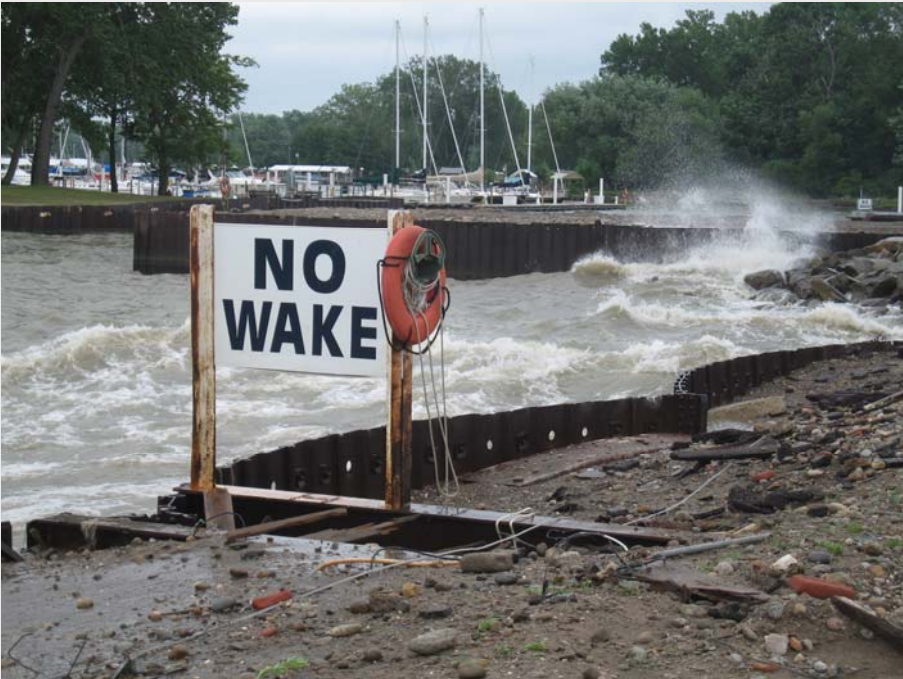
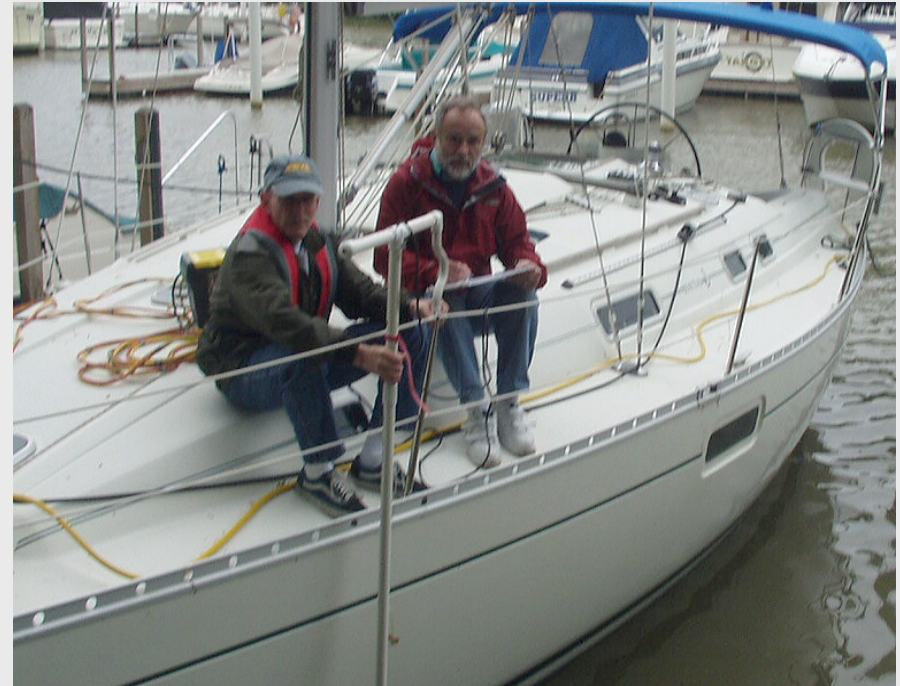
- The purpose was to find causes of accidents and recommend ways to make the marina environment safer
- We visited freshwater marinas nationwide over the past year
- Faults were introduced and the resulting electric fields measured around each boat
- Metal and FRP boats were tested in various propulsion and mooring configurations
- Here's some photos and sample page of actual data

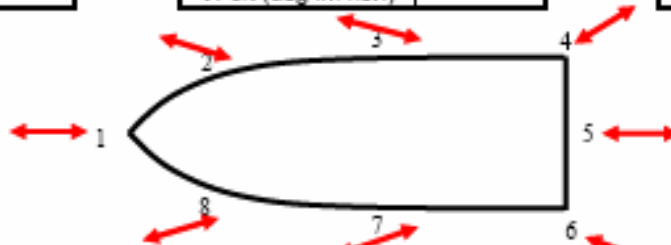
- Here's the field strength table blown up from the data page
- Note the lethal conditions around this boat, particularly at the stern and quarters (positions 4, 5 and 6)
