# Grounding and Bonding in Boats and Marinas

## A Vital Link to Safety

Capt. David E. Rifkin and James D. Shafer

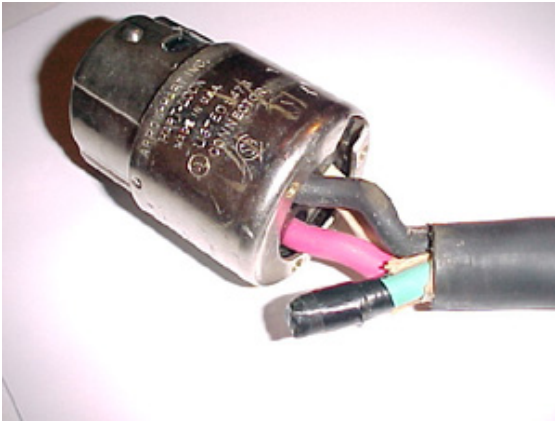
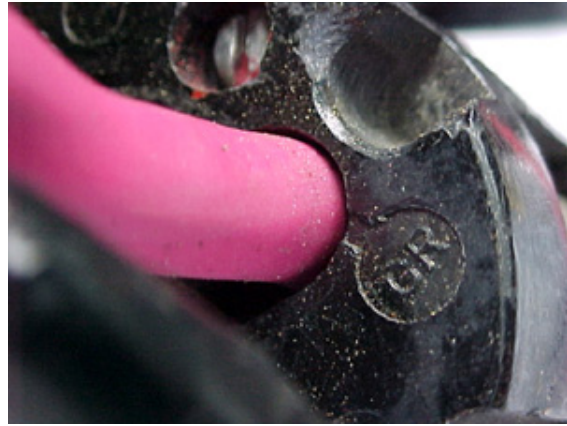
A recent incident should set the stage for our discussion. A quiet Memorial Day weekend turned tragic when a houseboat owner decided to install a new female plug on his shore cord so it would be compatible with his inlet receptacle. His boat was wired for 120vac but the cord was set up to supply 240vac. Please examine the result of his handiwork in the below pictures. Note that the green ground wire in first picture is taped back and not connected to the plug. In the second picture you can see that he inserted the red wire (the hot, ungrounded conductor) into the hole for the ground wire effectively electrifying the aluminum hull (and water surrounding the boat) *while eliminating the ground wire fault current return path.*

His wife and daughter were sunning themselves on the boat when they decided to go for a swim to cool off. After entering the water adjacent to the boat, they were both overcome by electric shock and drowned by the electric field established in the water.

This tragedy was the result of a ground fault and a loss of ground connection at the same time. This combination is what has resulted in numerous deaths in freshwater marinas nationwide. AC ground faults, along with ground system problems also result in boat fires each year. Faults in the bonding system of a boat, coupled with DC ground faults, contribute to significant cases of underwater metal corrosion.

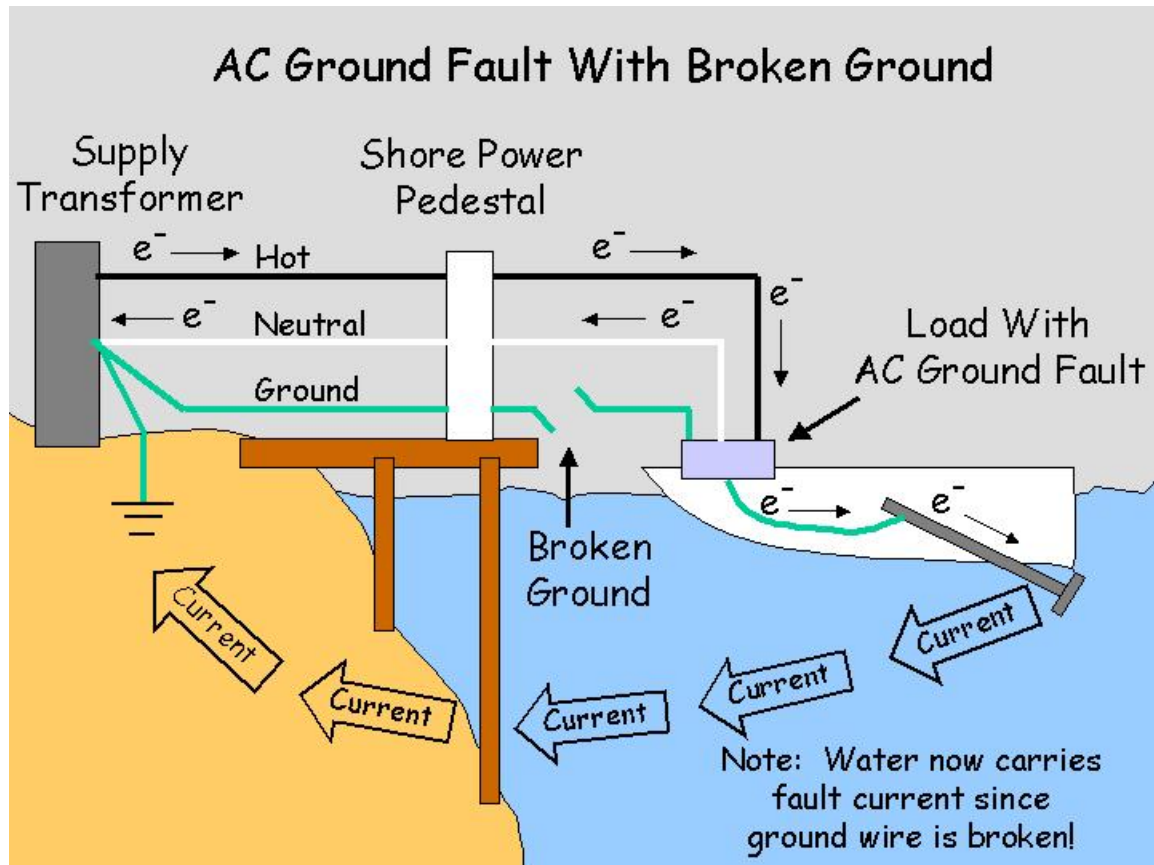
addresses this situation by requiring that the ground systems in all marinas be checked for integrity at least annually, along with visual inspections of marina wiring for compliance with code requirements. It also forbids personnel from entering the water in any marina where shore power is provided. Complying with NFPA 303 substantially reduces the likelihood of electric shock drowning. Please see the diagram below.

The path for current flow in the above situation may not be all that obvious. Here goes: AC current originating from the source reaches the load on the boat and 'sees' the possible fault path due to the ground fault. Since current takes all possible paths back to the source (proportioned based on the resistance of each path), and in this case the ground connection is poor or missing, the current can pass through a person touching this object and another object which is in electrical contact with the water (like an engine block, strainer, shaft, etc.). Once in the water, the current will find its way back to the source because where the green ground wire is attached to the source at the transformer, it is also staked into the Earth as a *ground* connection required by NFPA 70. In the case of a marina, this fault current can get back to the source through the water and soil until it reaches the ground stake, or, it can also get back through the underwater fittings of other boats connected directly to the green ground wire ashore.

From the above discussion we have revealed another source of personal injury; the electric field in the water caused by AC ground faults. The good news is that this is of little consequence in saltwater since the water is so conductive that the human body does not represent a lower resistance path for current to flow. However in freshwater, AC ground faults are a real threat, and in fact are killers. Remember that as long as the green ground wire back to the source is of low enough impedance, water currents will be low and create little voltage gradient. NFPA 303 (reference by NFPA 70) specifically
